Risk and vulnerability analysis, including an update of the restoration plan for the Hegga river

Report

Serial no: 8173-2026

Title	Pages	Date
Risk and vulnerability analysis, including an update of the restoration plan for the Hegga river	45	20.02.2026

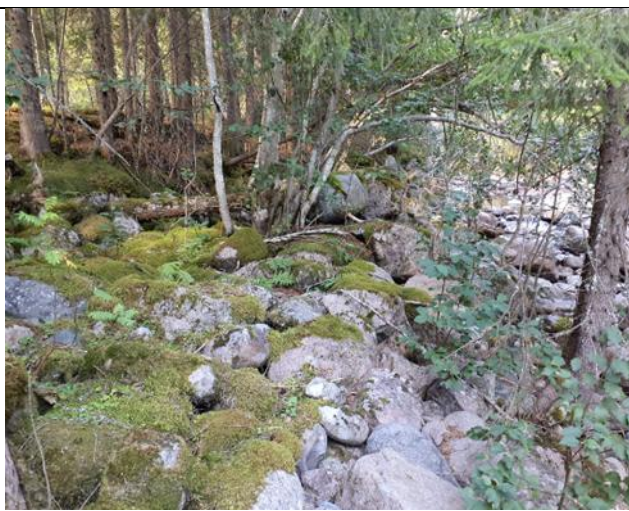
Figure 10. Example of vegetated boulder embankments that line much of the channel on both banks.

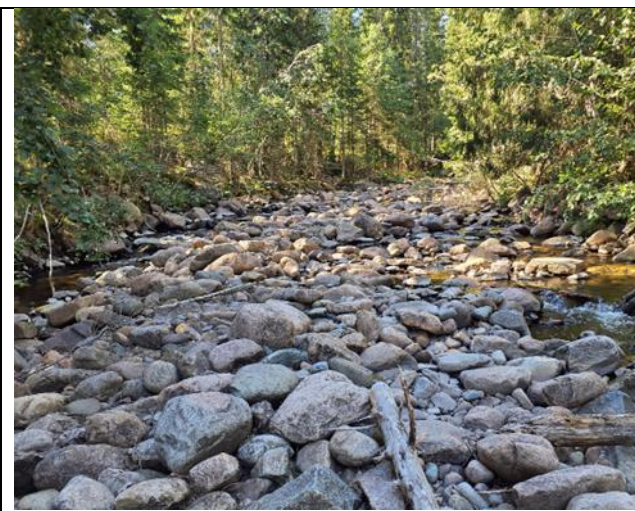
Figure 11. Example of boulder dominated surface materials along the upper sub-reach.

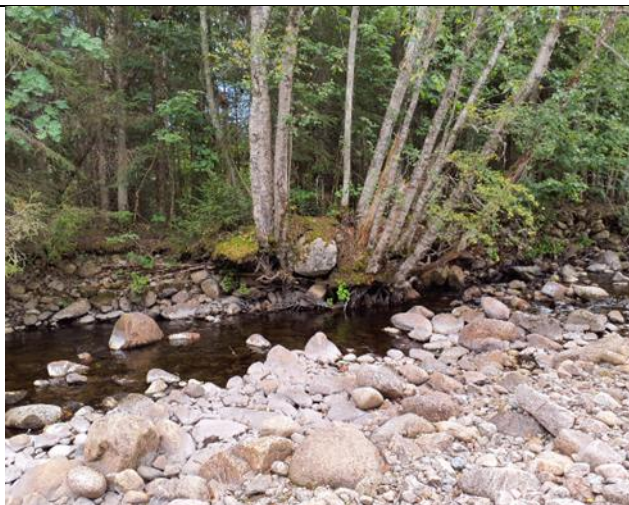
Figure 13. Example of an undercut bank with leaning trees.

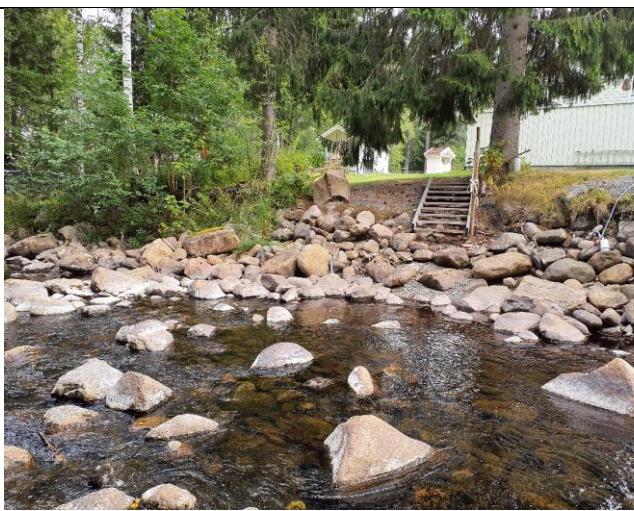
Figure 16. Properties located in close proximity to channel on South bank.

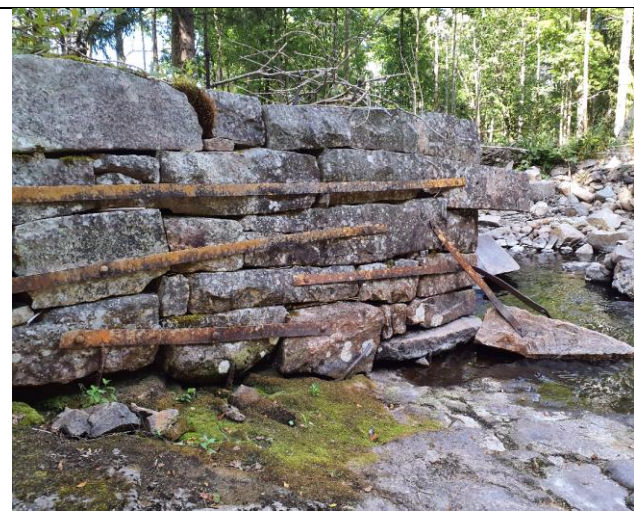
Figure 17. Example of hard bank protection. Note breached section on right side of photograph.

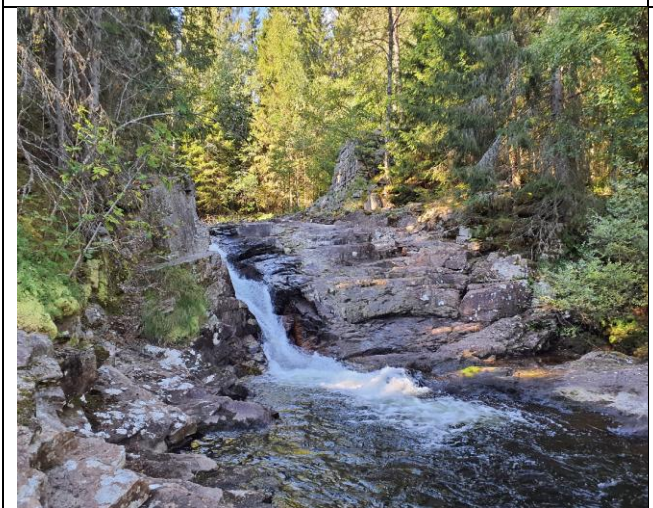
Figure 18. First waterfall is likely a barrier to fish.

- 6) **Fish Passage Mitigation:** Colman et al. (2019) proposed that the mitigation of the lower waterfall as a fish passage barrier was by blasting steps or sufficiently deep pools at its base to better facilitate fish passage. Although such an approach may prove successful, the NIVA-CBEC project team do not recommend blasting as means of mitigating a natural passage barrier.

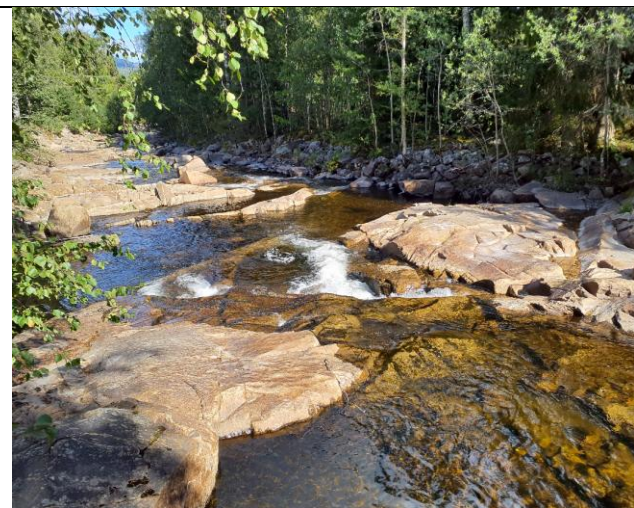
Figure 20. Exposed bedrock channel typical of the lower sub-reach.
