# Risk and vulnerability analysis, including an update of the restoration plan for the Hegga river

# Report

## Norsk institutt for vannforskning STI

Serial no: 8173-2026

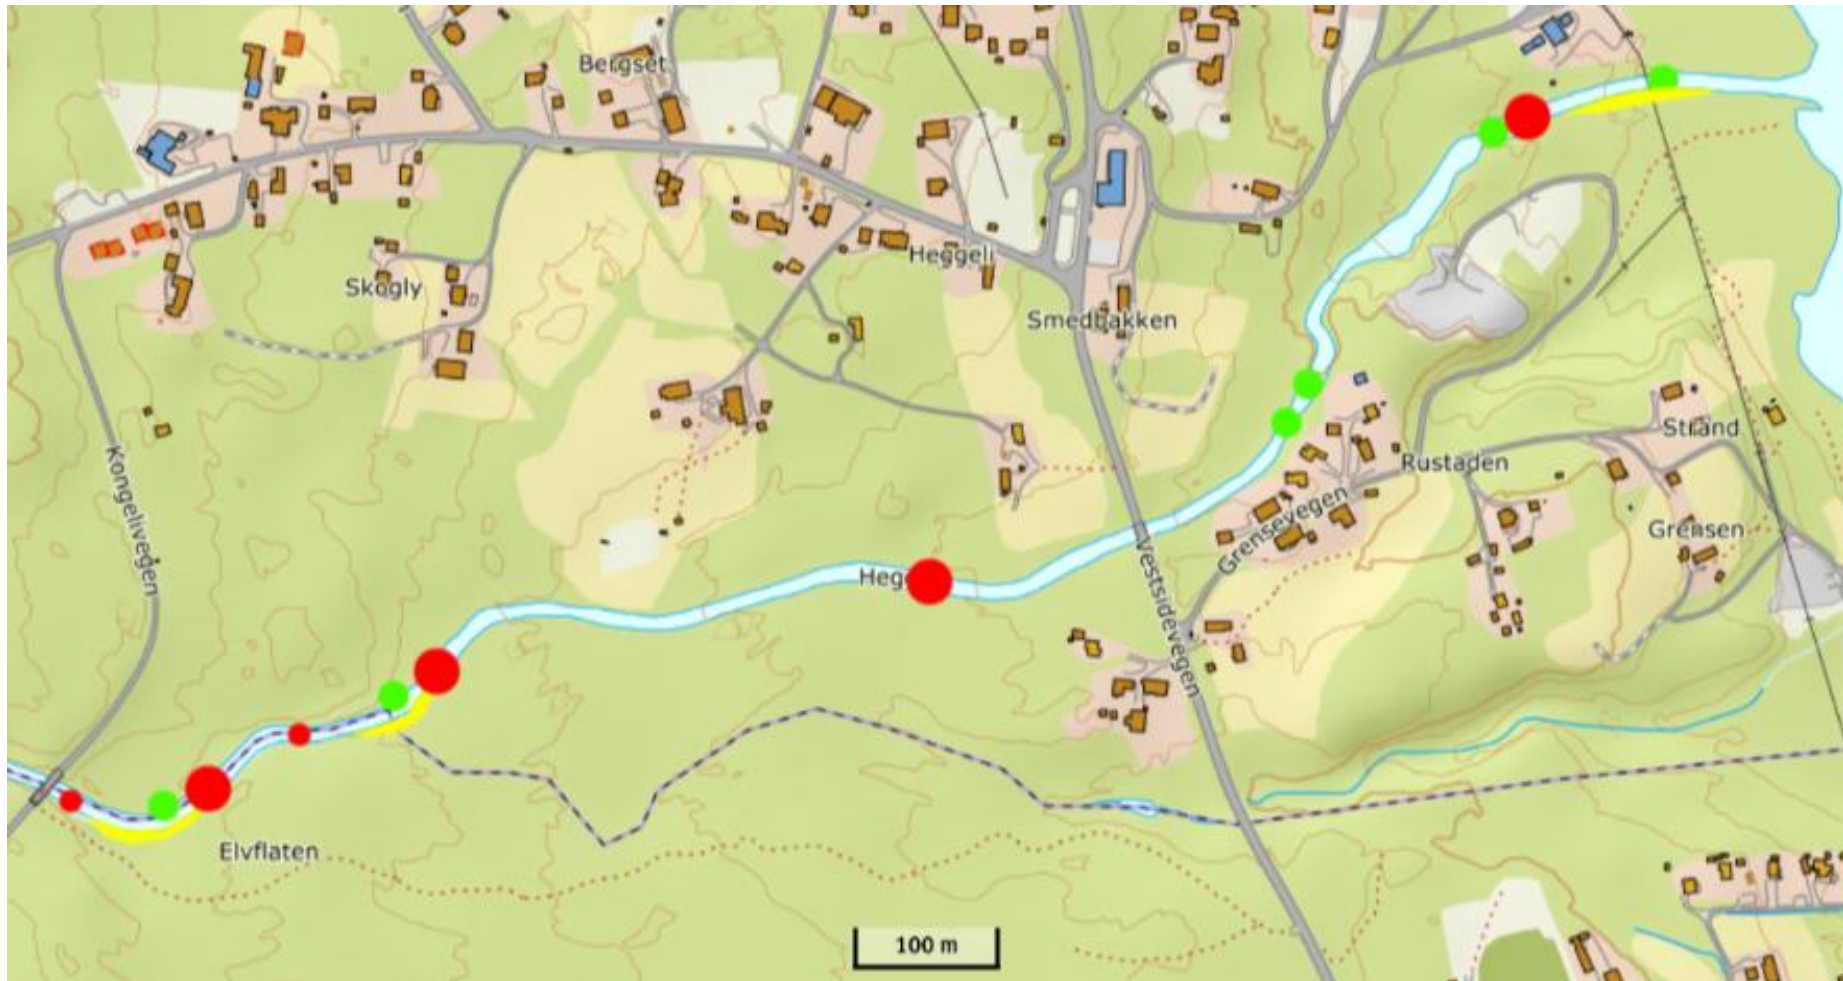
Figure 4. Measures proposed by Colman et al., 2019. Yellow areas indicate the proposed modifying of the riverbank. Green circles indicate the proposed excavation and stone reinforcement of pools. Red circles indicate proposed locations for spawning gravel placement. The size of the red circle (large/small) indicates the amount (high/low) of spawning gravel. Map base: Kartverket 2019 (WMS). Source: Colman et al., 2019.

The geomorphological field assessment phase commenced with an initial one-day reconnaissance site visit conducted by CBEC's Design Director on July 10th, 2025. This preliminary investigation was subsequently followed by a more extensive geomorphic walkover, which was performed collaboratively by an experienced CBEC geomorphologist and NIVA ecologist. This walkover facilitated a familiarisation of local geomorphic and hydrological processes and provided a basis for evaluating the feasibility of implementing nature-based solutions. This included the assessment of option proposals originally put forward by Colman et al. (2019) – see Section 1.3.3 and Figure 4.

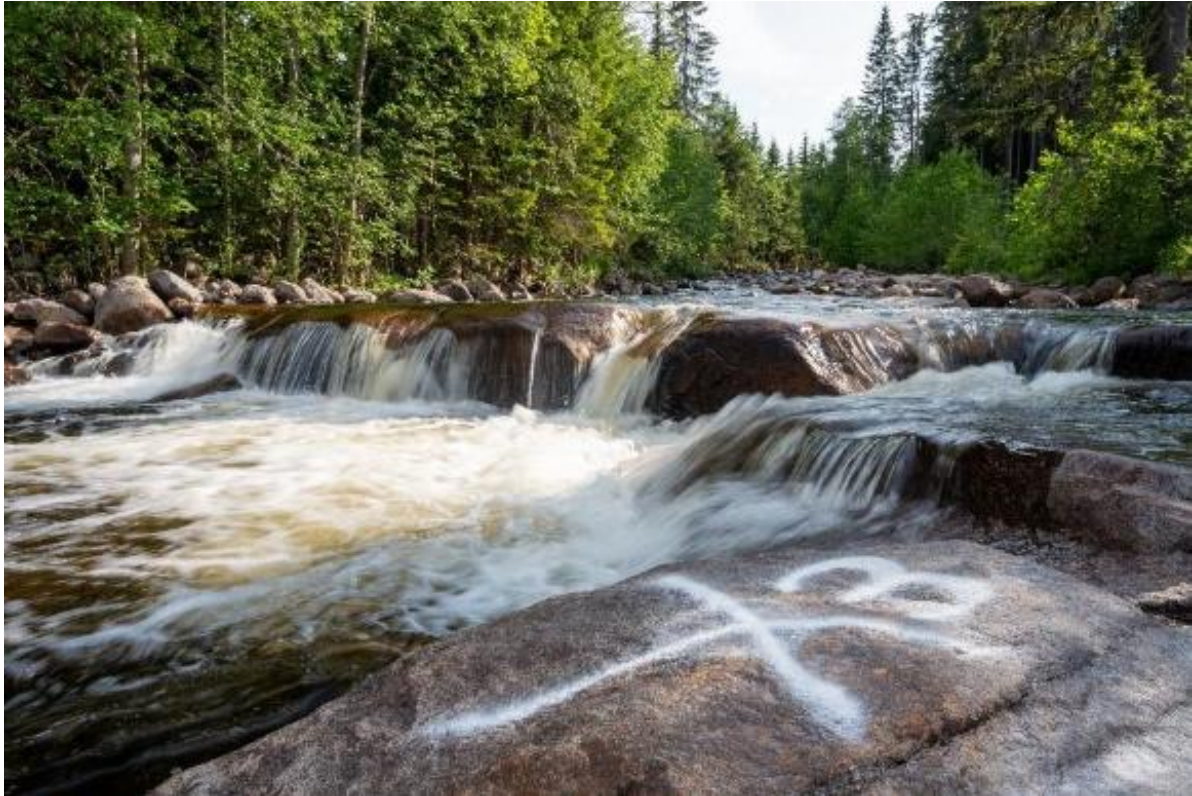
Figure 5. Ground control point near a rapid, marked with environmentally friendly chalk spray.

Turbidity measurements (FNU) do not register air bubbles, which can reduce the penetration depth of green LiDAR. In sections with churning water/rapids, air entrainment yields lower point density in the LiDAR data (Figure 5 & Figure 6).

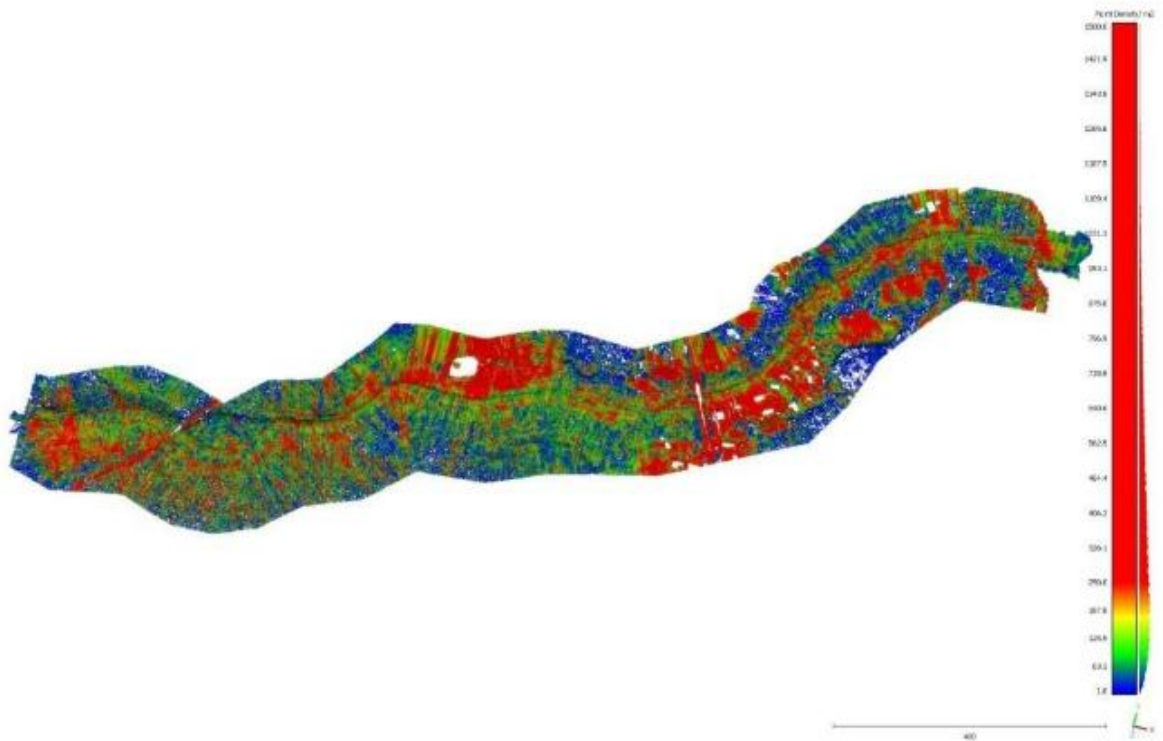
Figure 6. Point-density map for green and red LiDAR.

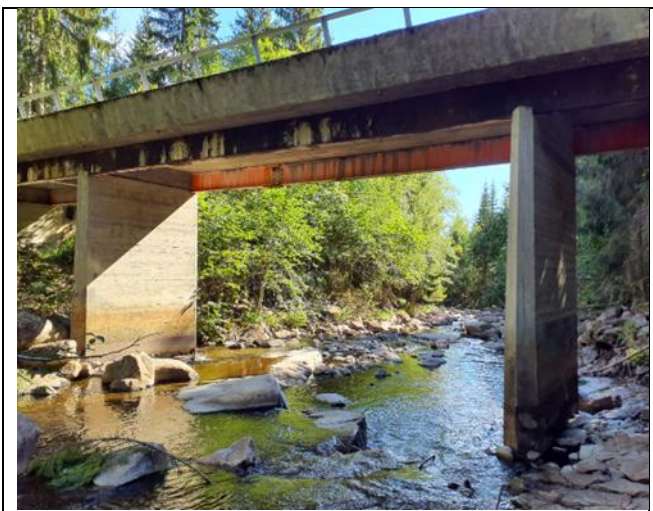
Figure 9. Bridge at the upstream extent of the survey area.

On the walkover undertaken 19th August 2025 during atypically low flow conditions<sup>3</sup>, the channel was wadable and bed material visible in most locations. For reporting purposes, the study reach can be divided into two sub-reaches; The upper sub-reach extends from the Kongelivegen Road Bridge (Figure 9) to the shore at Hurdalssjøen.

The composition of the bed surface material varies along the profile, reflecting changes in stream power, gradient, and local geology. The upper sub-reach is dominated by mobile boulder/cobble assemblages (Figure 11), with localised sections of exposed bedrock (e.g. at the bridge, see Figure 9), indicating high stream power or strong structural control. Apart from localised clusters, only the section above the FV 120 road bridge exhibited the presence of significant amounts of finer bed material, with increasing proportion of cobble sized material. This section coincides with an area on the north bank that floods episodically<sup>4</sup>, but also the presence of active side channels off the south bank – suggesting preferential deposition under high flows, relative to the stretch upstream. The lower sub-reach, however, showed an increase in the extent of exposed bedrock (Figure 20) and valley confinement. At the lowermost extent of the sub-reach the gradient drops off suddenly as the river meets the Lake Hurdalssjøen. Here the channel bed was characterised by a significant depositional zone (comprising coarse cobble/boulder size material).

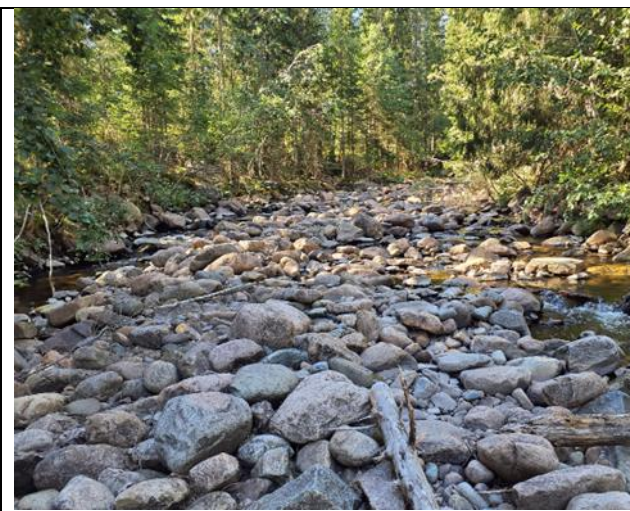
Figure 11. Example of boulder dominated surface materials along the upper sub-reach.

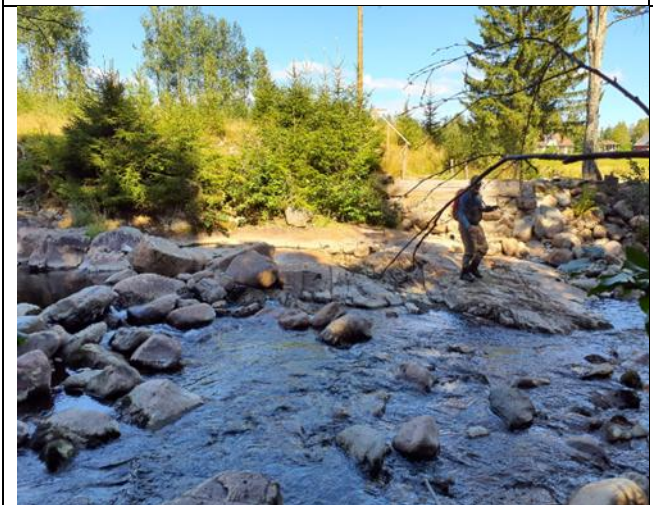
Figure 12. Note presence of bedrock outcrops. Looking towards left bank

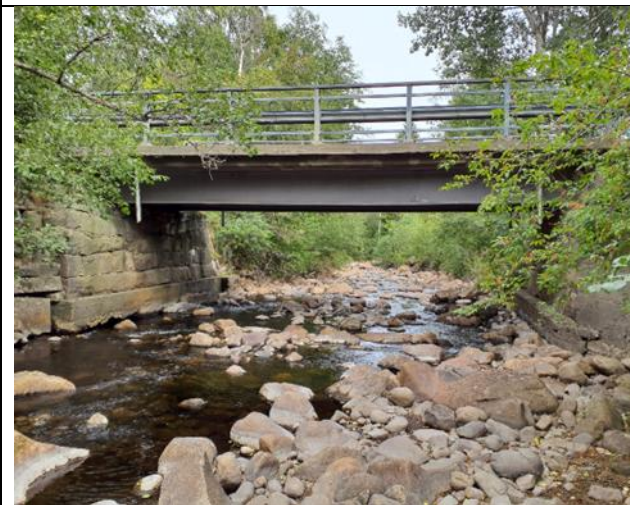
Figure 14. FV 120 road Bridge approximately mid-way along the study site. Looking downstream.

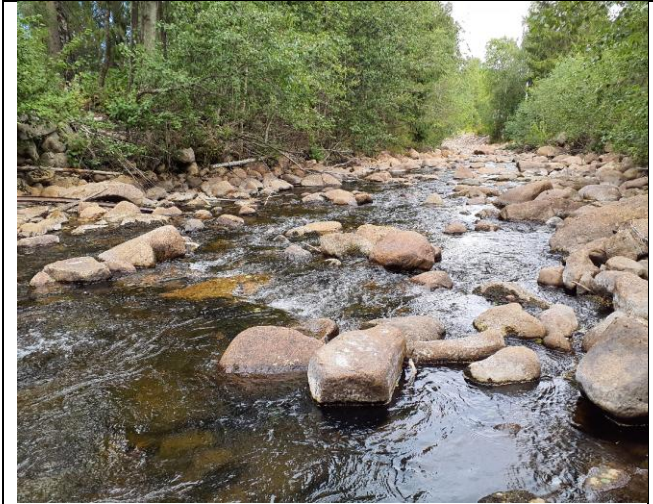
Figure 15. Typical steep boulder dominated channel. Note densely wooded channel banks.

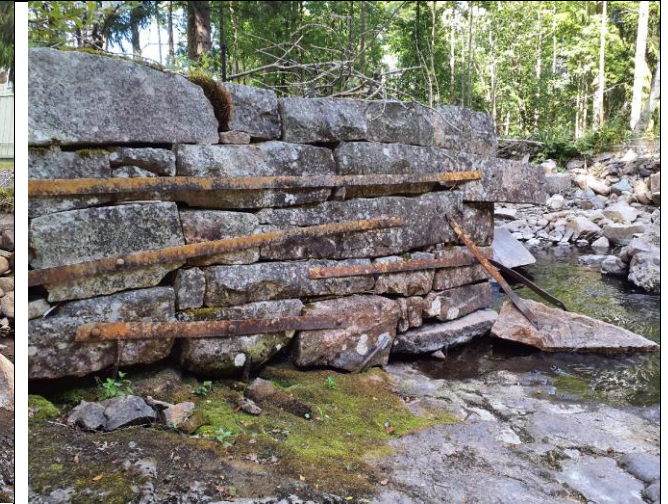
Figure 17. Example of hard bank protection. Note breached section on right side of photograph.

presence of adjacent properties (specifically on the south bank) this also coincides with the presence of hard bank protection. Other localised sections of hard bank protection were associated with a disused mill race (Figure 17) which showed evidence of breaching on the day of survey (attributed to storm Hans – 7th August 2023). The dominant man-made pressure however was the presence of extensive boulder embankments which were observed to line much of the channel on both banks. Although originally constructed as part of management practices to better facilitate the floating of logs, these also now act as flood embankments, disconnecting the channel from its floodplain.

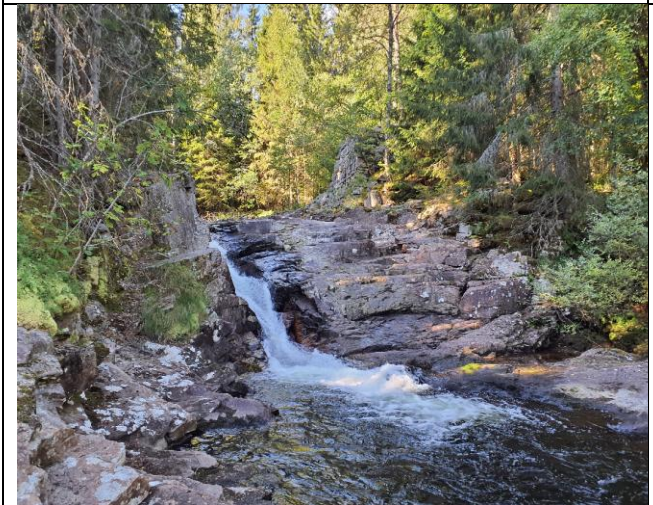
Figure 18. First waterfall is likely a barrier to fish.

Other significant features along the system included the presence of two natural waterfalls in the lower sub-reach (Figure 18 and Figure 19), one of which is acknowledged as a barrier to fish migration upstream. The presence of bank erosion (Figure 13), which locals partially attribute to the transport of ice flows and boulders during high-flow events, was recorded along isolated sections of both banks, with the most significant examples seen along a 150 m section below the FV 120 road Bridge. Given the

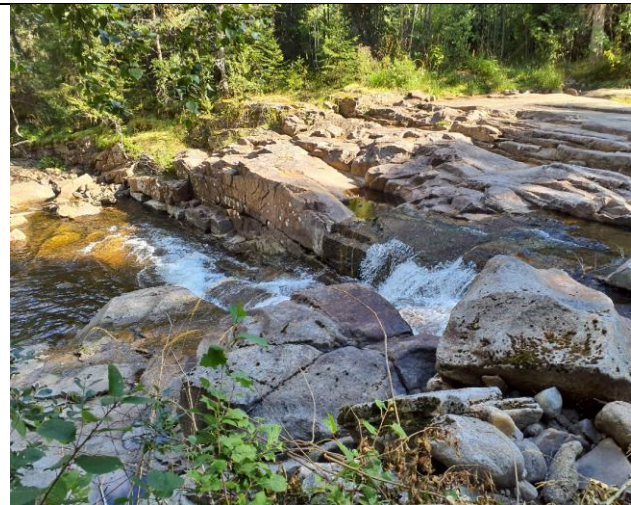
Figure 19. Second waterfall along survey area.

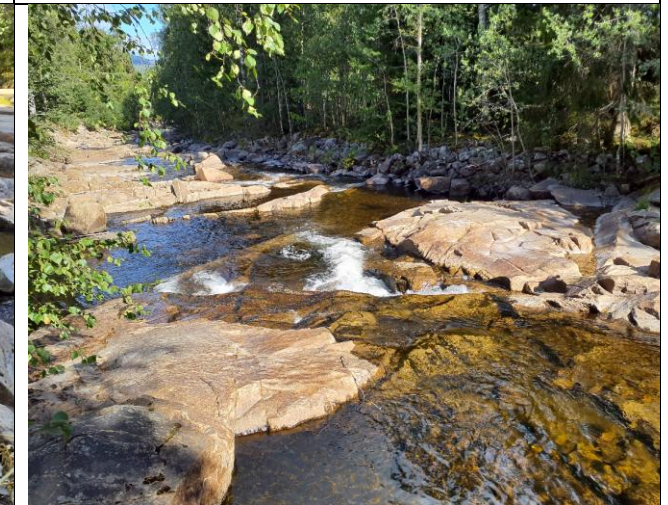
Figure 20. Exposed bedrock channel typical of the lower sub-reach.

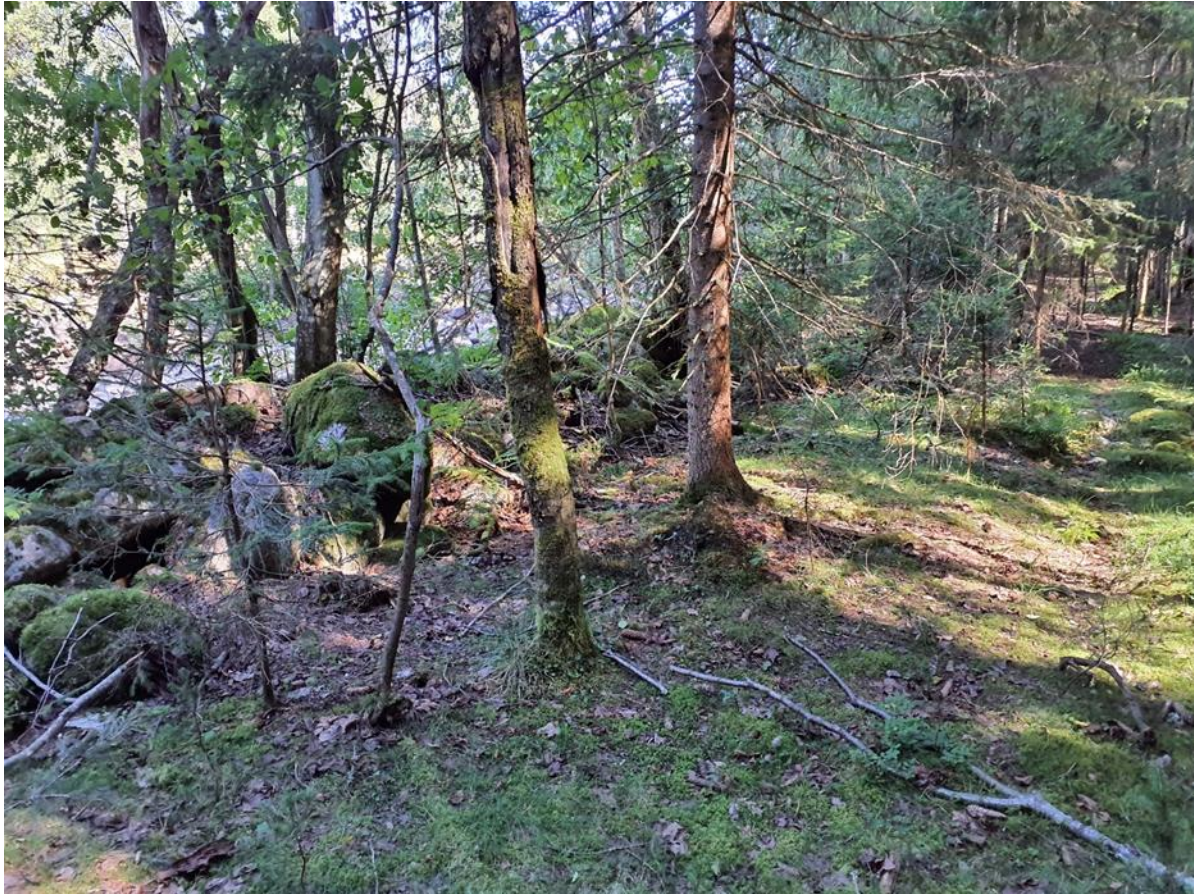
*Figure 21. Example of boulder embankments that disconnect the channel from its historic floodplain.*

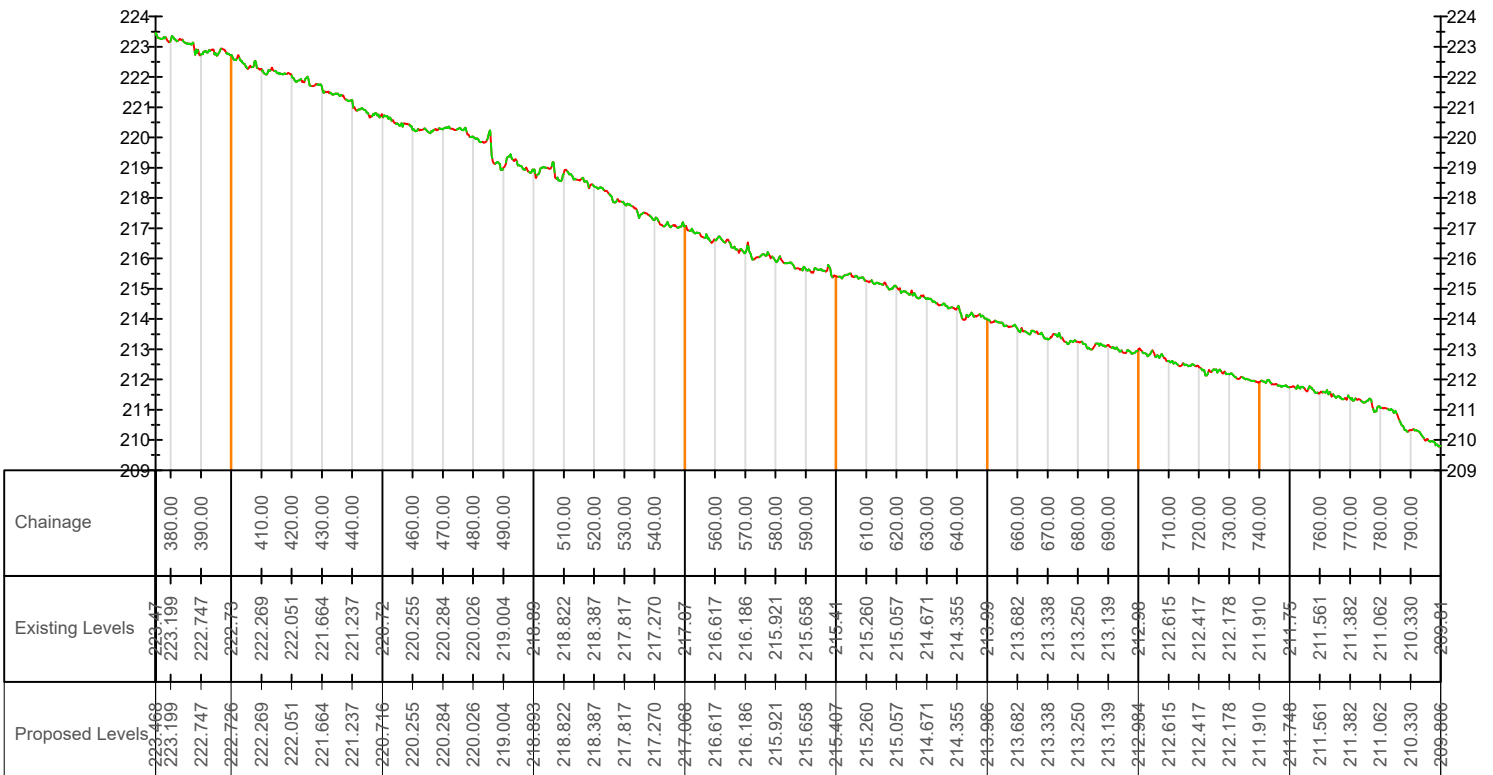
HEGGA RIVER - LONGSECTION  
 SCALE: H 1:1000, V 1:100, DATUM: 209.000  
 x10 vertical exaggeration

Drawing Title: DETAILED DESIGN LONG PROFILE MC
